Middle Branch Passive Treatment System Rehabilitation Project

Prepared by Hedin Environmental
For Trout Unlimited and the Kettle Creek Watershed Association

June 2007

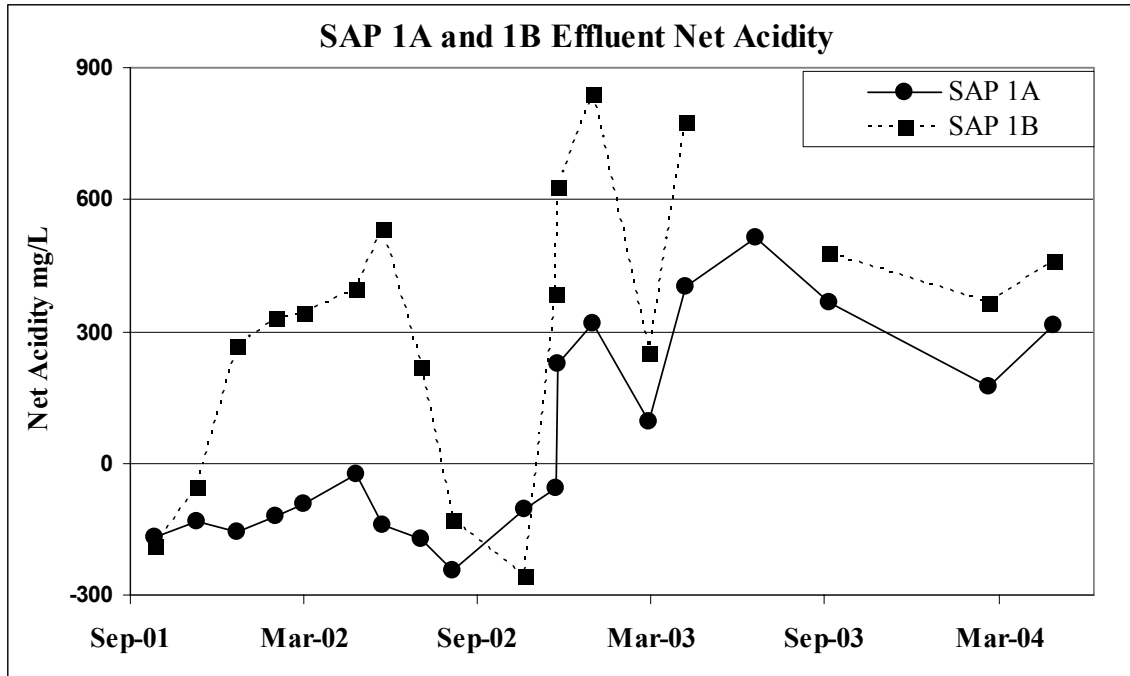
From an effluent water quality perspective SAP 1B declined abruptly in performance by January of 2002, just one year after the system came online. SAP 1A maintained alkaline effluent until December 18, 2002, almost exactly one year longer than SAP 1B. Figure 1 shows the net acidity of both SAP 1A and SAP 1B over time.

Figure 1. SAP 1A and 1B effluent net acidity over time. SAP 1A produced alkaline effluent one year longer than SAP 1B.

On December 17, 2002 both SAP 1A and 1B were flushed. Up to this point, SAP 1A was producing net alkaline effluent. Every sample collected after this point was net acidic. The reason for this reversal is unclear. It is possible that one of the valves connecting the two SAP ponds was opened during the flushing allowing more flow from the R2 discharge to enter SAP 1A.

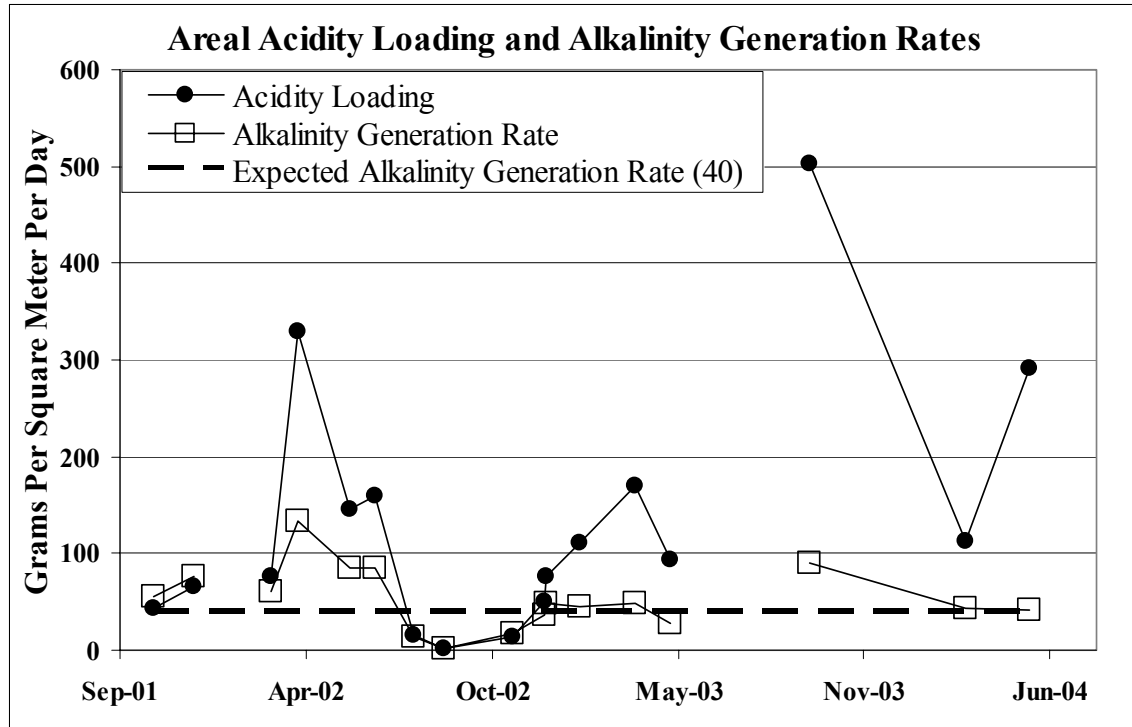
Figure 2. Comparison of total system influent loading and combined alkalinity generation rates of SAP 1A and 1B. The expected rate of alkalinity generation is also shown. The alkalinity generation rate was within the range of expected performance even in May of 2004 well after the system was declared to have “failed”.

The overloaded situation is clearly illustrated in Figure 2. The average influent loading was three times the expected treatment capacity. The loading during several high flow events was 8 – 12 times more than the treatment capacity.

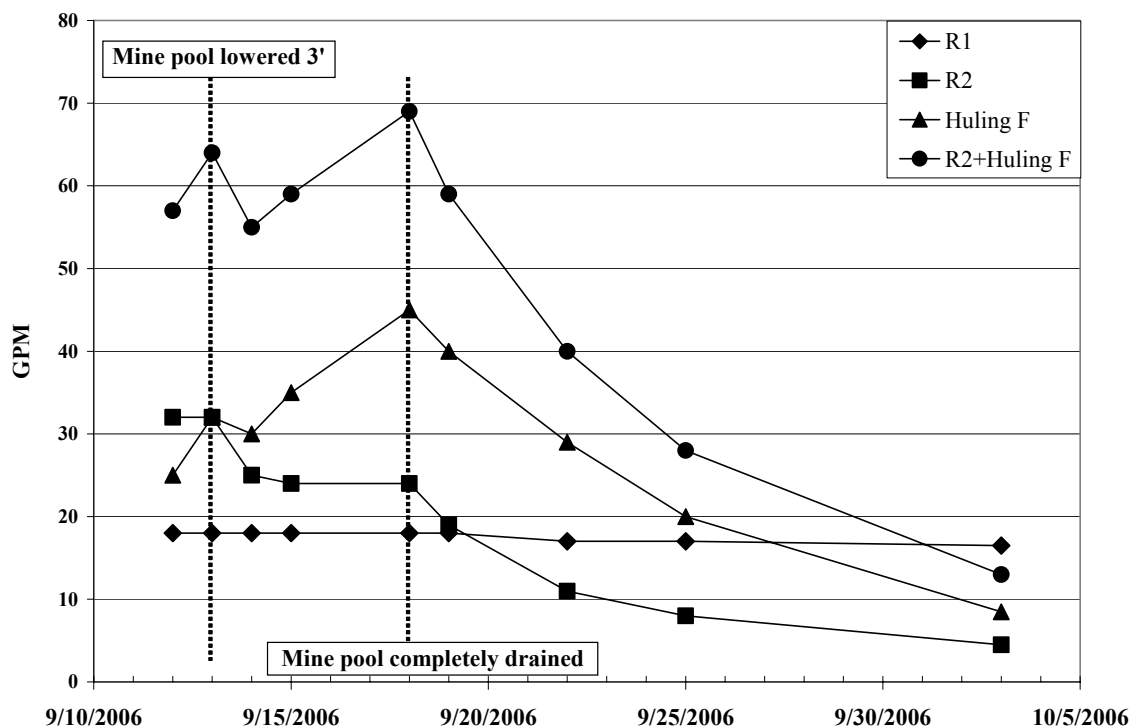
The diversion of the AMD caused a substantial decrease in the flow of the R2 discharge. Figure 3 shows flow rates in the three weeks following the project's initiation. The R2 flow rate decreased immediately after the installation of the collection system. The flow of R1 did not change during this period. Figure 3 shows the response of the R2 discharge to dewatering of the deep mine.

Figure 3. Relationship of flow between the Huling F collection system and the R1 and R2 discharges. Flows at R2 responded immediately to collection

Since installation, the Huling F collection system has discharged 2-3 times more flow than the R2 discharge. Despite above normal precipitation in October and early November, the R2 discharge had a maximum observed flow rate of 45 gpm on November 14, 2007. In the past, similar precipitation conditions would have resulted in flows exceeding 100 gpm. The total flow from R2 and Huling F on this date was 113 gpm. It is likely that this approximates the R2 discharge flow without collection. The installation of the collection system has successfully diverted high flows and loadings away from the treatment system.
