KC204 Mine Pool Stabilization Project

**By Hedin Environmental
For Trout Unlimited & the Kettle Creek Watershed Association
June 2011**

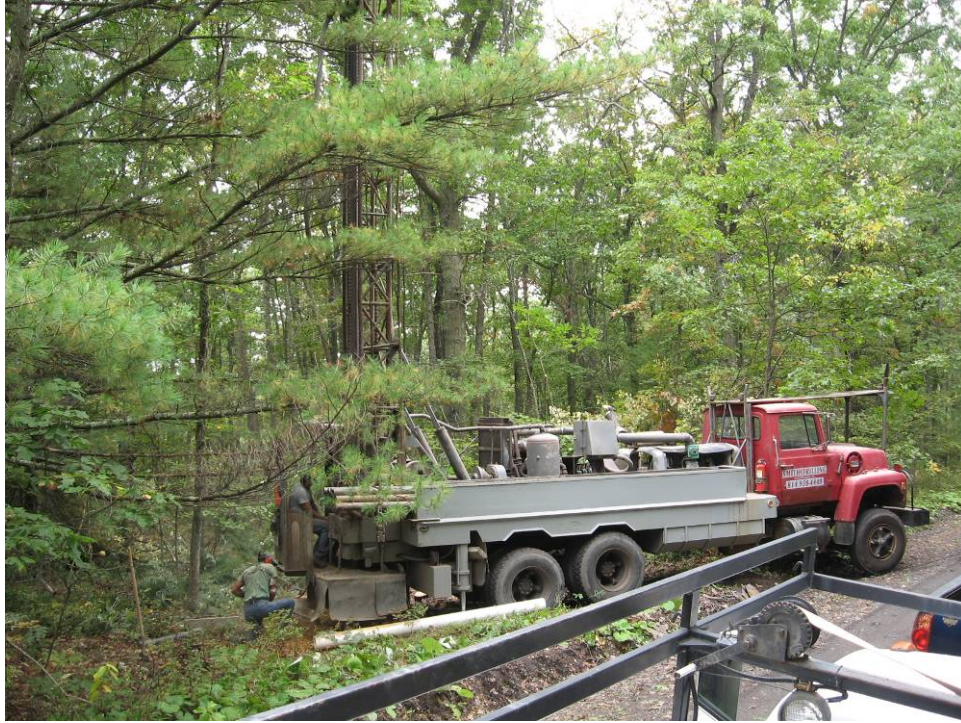
A new monitoring well was installed so that water elevations in the mines could be monitored. The drilling occurred September 24-25, 2009 by Smith Drilling (Brookville, PA) using an air rotary drill. Initially the drilling occurred along Cattaraugus Road. Unfortunately, bedrock fractures caused the drill bit to jam in all of the holes along Cattaraugus Road before the coal seam was reached. It is believed that the fracturing is due to unloading along the edge of the steep slope. When the rig moved west of the road, it was able to drill successfully into the underlying No. 3 mine. The hole was cased and capped for use as a monitoring well (identified as BIT 13). Two monitoring wells that were installed prior to this project (BIT 3 and BIT 9) penetrate the workings of Mine No. 1. Together these three wells allowed for monitoring of mine pool elevations. The location and elevation of the monitoring wells was surveyed by DEM Surveying of Brookville, PA. Map B shows the location of the monitoring wells.

Drilling along Cattaraugus Road

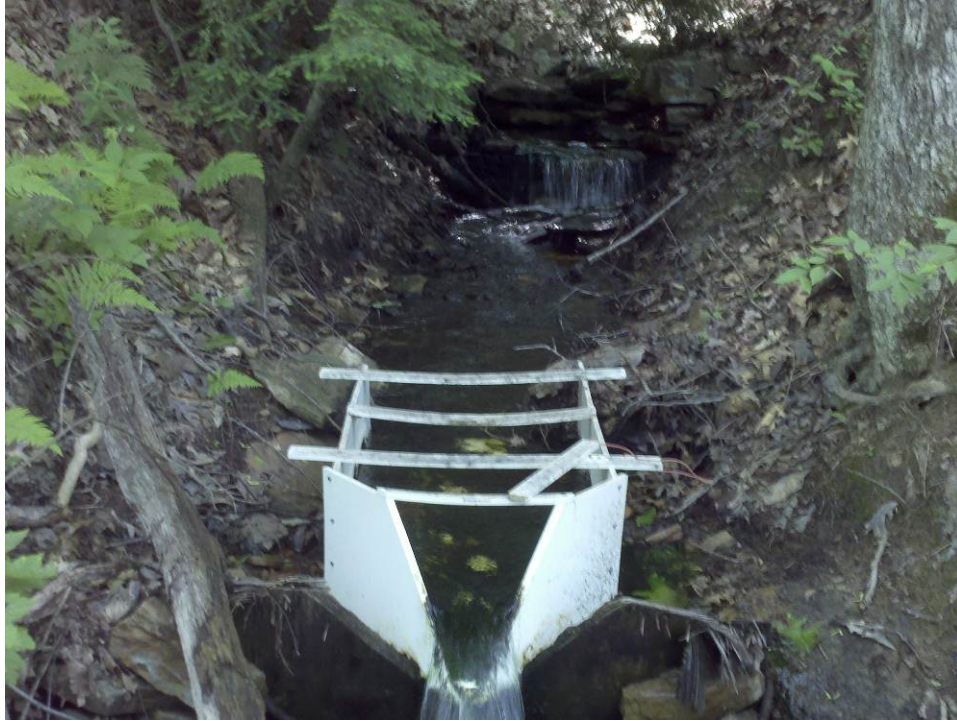
KC204 discharge and H-flume

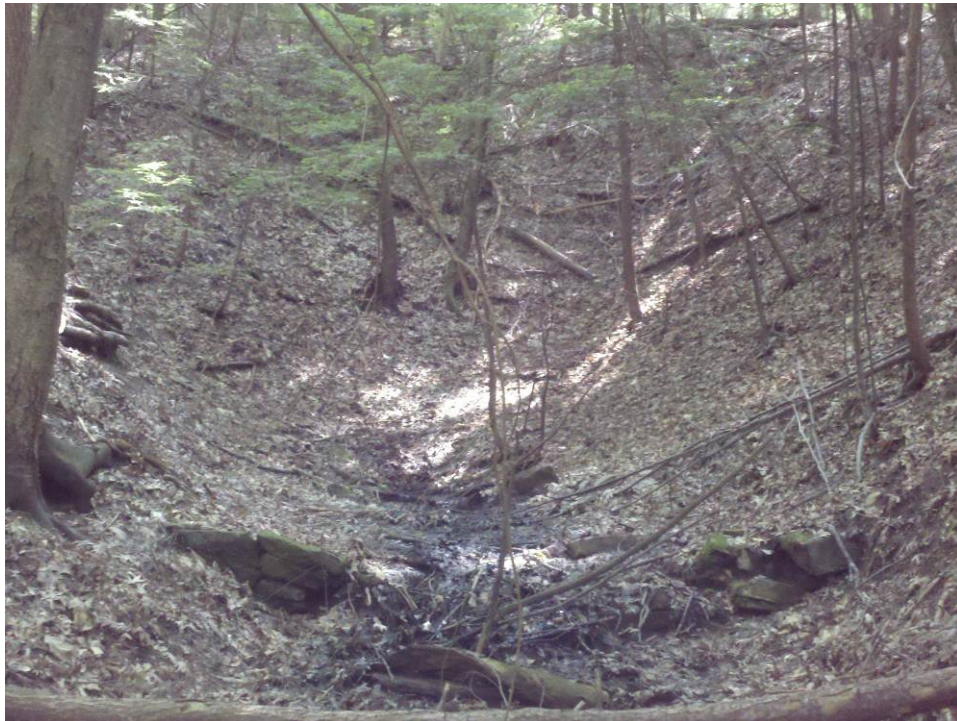
Since at least 2002, the only free flowing drain for several hundred acres of deep mine workings above Kettle Creek was KC204. If the KC204 discharge were to become obstructed, water levels in the mine would rise and a blowout would likely occur. Or, if the KC204A blockage were to be released, a blowout-like event would occur. Because the water in the mine is highly acidic (> 600 mg/L), a rapid release of a large volume would devastate lower Kettle Creek and the West Branch Susquehanna River below Westport.

Collapsed KC204A drain

To reduce the risk of such an environmental disaster, this project reestablished drainage from two of the entries at the inclined plane above Milligan Run. Reestablishment of flow through the KC204A drain was considered impractical and was not pursued for several reasons. First, the drain is located on a very steep slope that makes access with equipment difficult and expensive. Second, the KC204A drain is located at the base of the mine pool so the pool would have to be pumped down prior to any work on the drain. Pumping would be costly and would not completely eliminate the threat of the release of mine water from isolated pools near the drain. And third, the increased flow of AMD from KC204A that would result from the drain's repair would cause more acidic water to flow to Kettle Creek and deleteriously impact the recovering fishery in lower Kettle Creek.

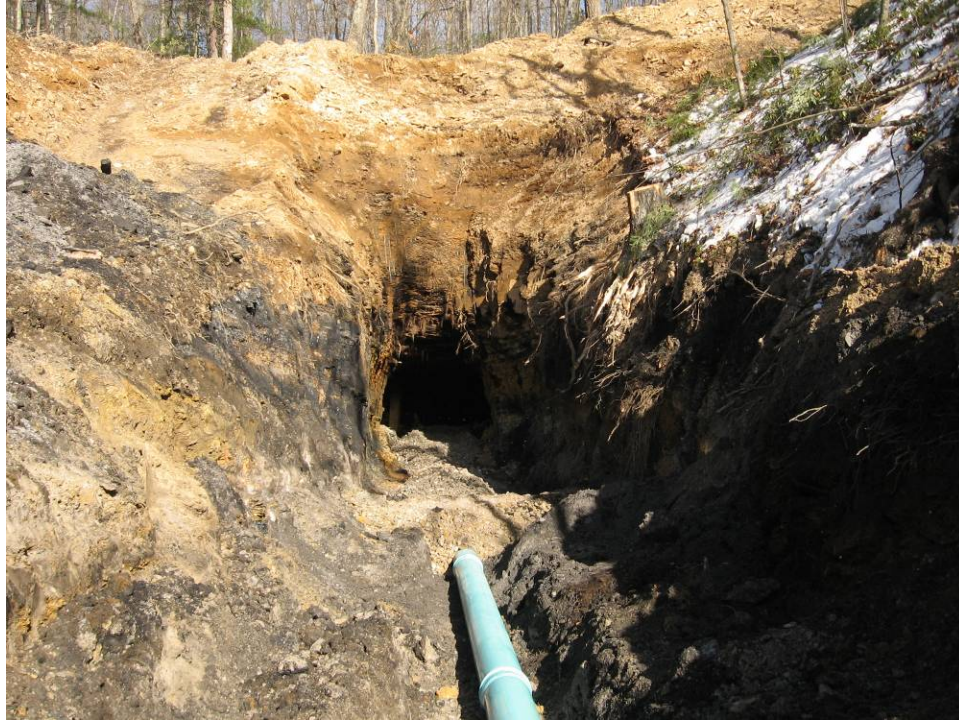
The Mine 1 entry was completely excavated and a drain was installed on the mine floor. The mine was dry at the time of excavation and evidence of a wooden box drain was found between the crossties of the railway. The new drain consists of 10-inch PVC perforated pipe in a bed of non-calcareous aggregate. A clay dam was installed across the mine opening immediately downstream of the perforated pipe to prevent leakage along the pipe. Solid 10-inch PVC pipe carried the flow from the mine entry to the discharge location 300 feet downslope to an existing kill zone. An energy dissipater lined with riprap was installed at the outfall to prevent erosion.

Mine 1 entry with pipe and aggregate.

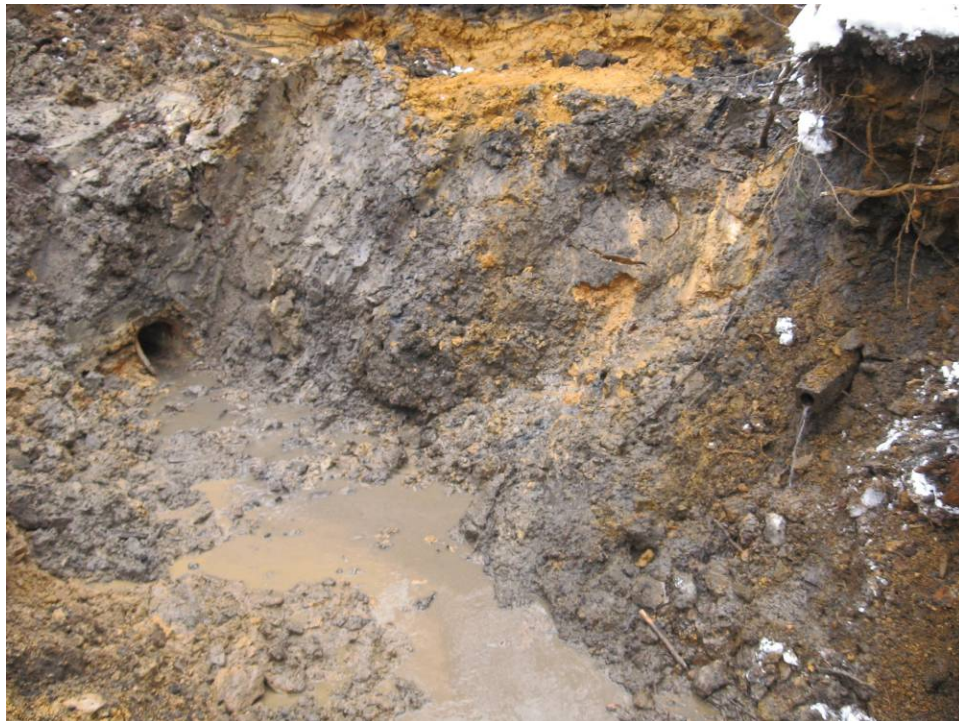
During the excavation of Mine 1 a pipeline was discovered that ran parallel to the coal crop toward the entries of Mine 2. The pipeline was excavated and found to consist of a mixture of 2-inch metal and wooden pipe. In front of the eastern most entry to Mine 2 (Mine 2a) the excavation encountered a large log cribbing that was filled with saturated sediment. The cribbing was located directly beneath an old weir for monitoring flow from the Mine 2a entry. Sediment was excavated from the cribbing which revealed a 12 inch clay pipe that had served as a drain for the mine. The clay pipe was discharging water. The land above the entry was severely subsided so opening the entry to replace the drain properly would involve significant excavation and was considered impractical. Instead, a 10-inch PVC pipe was connected to the existing clay pipe using a Fernco fitting. The PVC pipe was extended downslope to an existing kill zone where an energy dissipater lined with riprap was installed at the outfall to prevent erosion.

Mine 2a drain was connected to the clay pipe near the left center of the photo. The wooden pipe discharging water near the right edge of the photo extended to and past the Mine 1 entry.

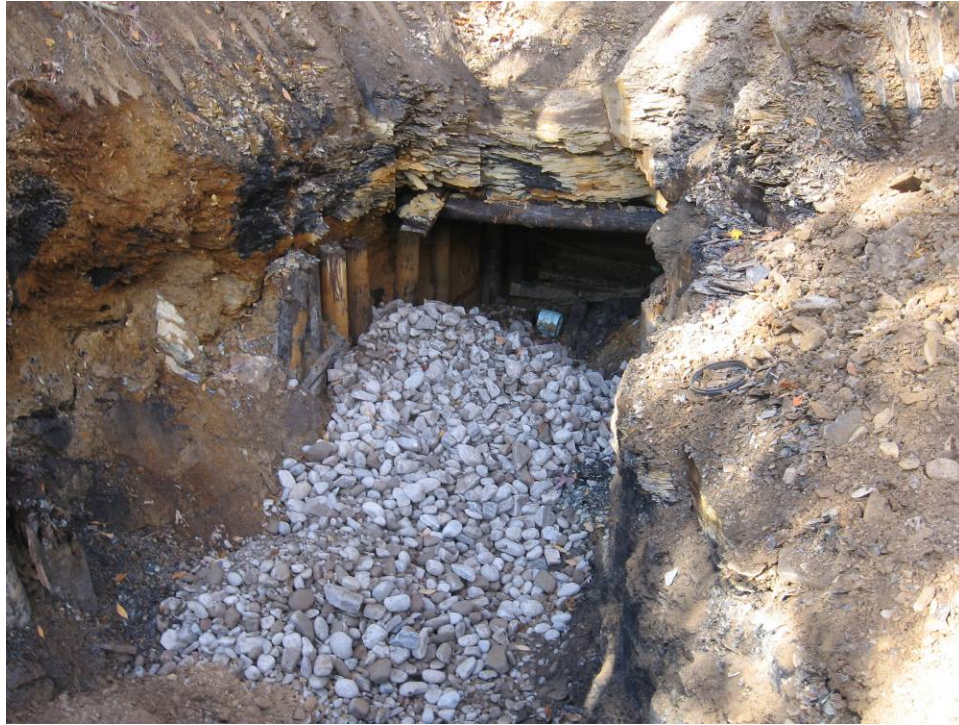
The next entry west of Mine 2a was excavated. It was chosen due to its apparent lack of subsidence upslope of the entry indicating that a clear connection to the main mine workings may exist. Once opened it became clear that it was a primary entry to Mine 2. The roof was heavily timbered and large pillars supported the roof on both sides. No roof subsidence was visible from the exposed entry. During excavation a 24-inch diameter clay pipe was discovered that had served as a drain for the mine. The clay pipe was filled with iron solids and the outlet end was crushed and filled with earth. A new drain was installed on the mine floor. The new drain consists of 10-inch PVC perforated pipe in a bed of non-calcareous aggregate. Just inside the entry a section of perforated pipe was pushed into an adjacent room that was producing significant flow then connected to the main pipe with a wye fitting. A clay dam was installed across the mine opening immediately downstream of the perforated pipe to prevent leakage along the pipe. Solid 10-inch PVC pipe carried the flow from the mine entry to the discharge location 280 feet downslope in an existing channel. An energy dissipater lined with riprap was installed at the outfall to prevent erosion.

Mine 2b entry excavated with pipe and aggregate in place

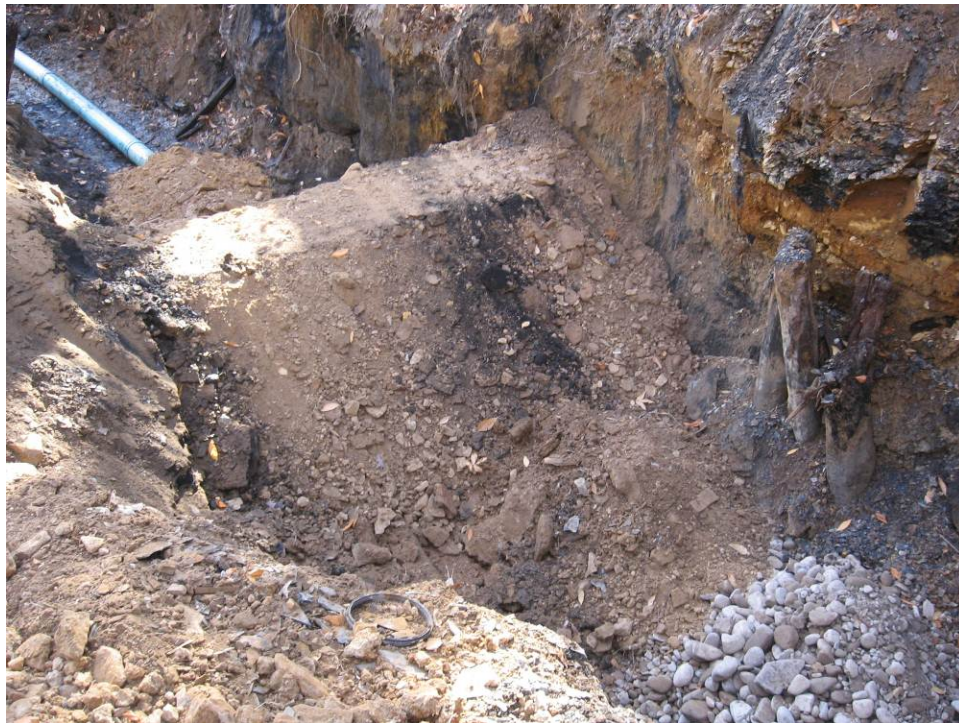
Compacted clay dam in Mine 2b entry

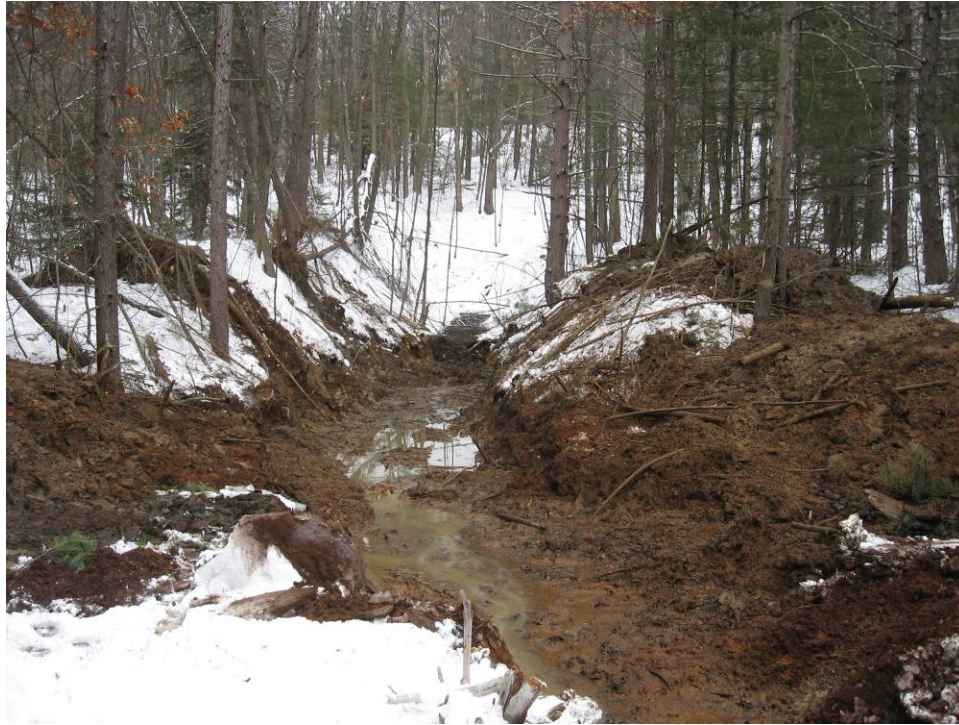
An apparent collapsed drift entry was excavated to provide drainage based on the presence of a small kill zone at its mouth. Once opened, the entry was found to be into a small room cut parallel to the crop that dead-ended 20 to 30 feet to the west of the entry and was blocked by subsidence to the east. No heading was found to the north that would have connected the entry to the main workings. Removal of the subsidence would have involved creating a significant and potentially dangerous highwall during construction so no effort was made to remove it. Instead, a drain was installed on the mine floor which consists of a 10-inch PVC perforated pipe in a bed of non-calcareous aggregate. A clay dam was installed immediately downstream of the perforated pipe across the mine opening to prevent leakage along the pipe. Solid 10-inch PVC pipe carried the flow from the mine entry to the discharge location 270 feet downslope to an existing channel.

Mine 2c excavated to the mine floor.

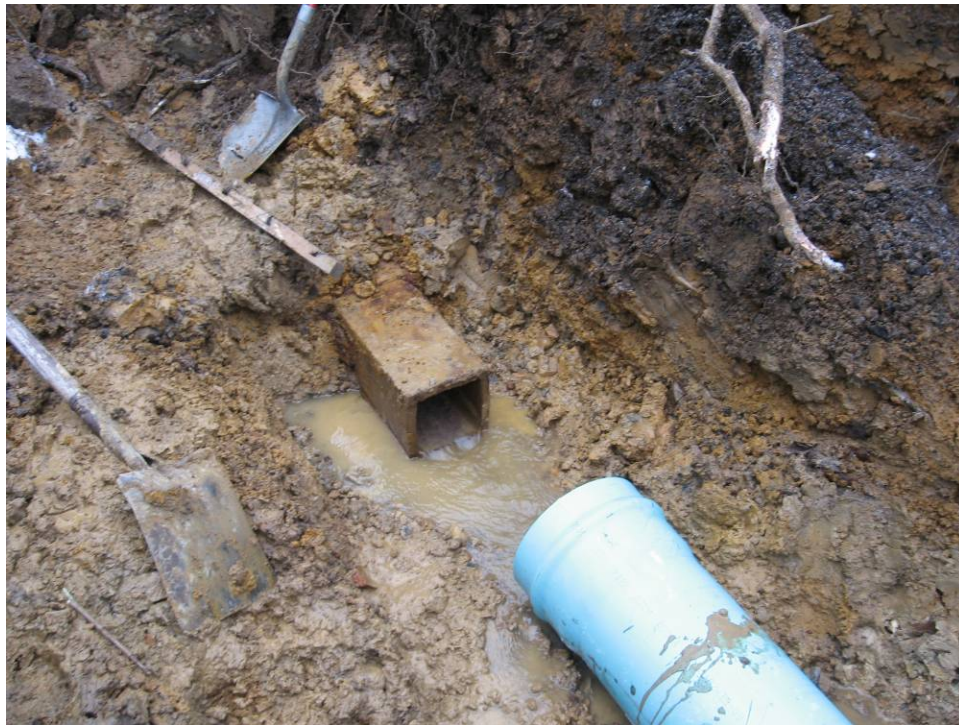
Mine 3 lies west of the inclined plane between Crowley Hollow and Cattaraugus Road. The entry into Mine 3 is perpendicular to the other entries at the inclined plane and about 10 feet of elevation higher than the other entries. Excavation of the mine entry encountered a square clay pipe. The pipe was discharging water at the time of excavation. A Fernco fitting was used to connect a 10-inch PVC pipe to the square clay pipe. Clay was packed around the joint to seal the imperfect fit of the round fitting to the square pipe. The 10-inch PVC was directed to the existing discharge channel.

Mine 3 drain uncovered. The PVC was connected to the clay tile using a Fernco fitting and compacted clay.

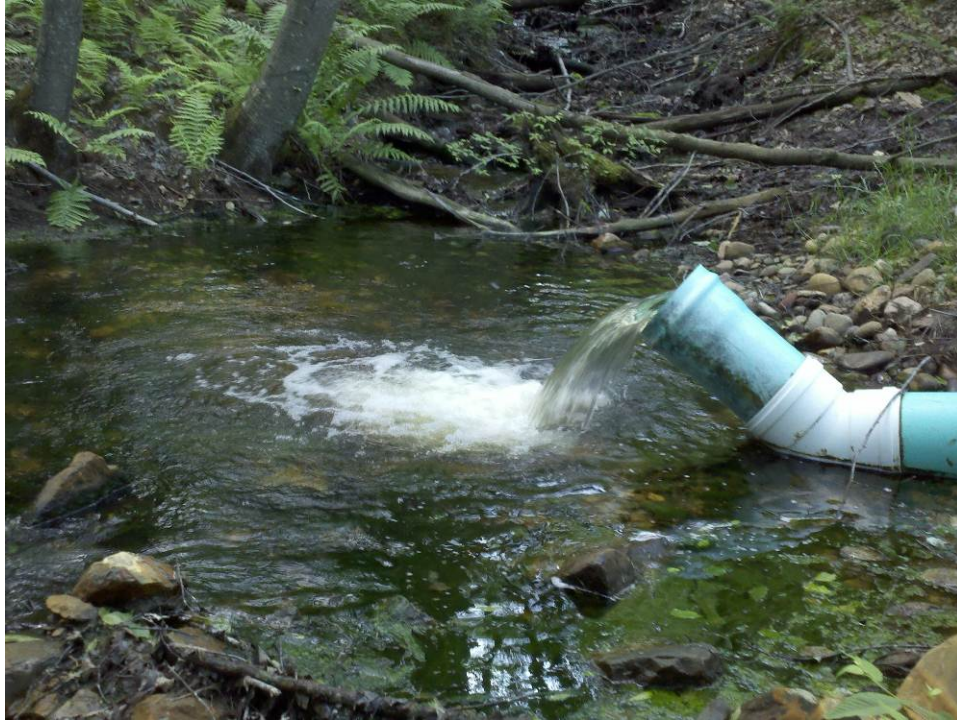
Mine 2b outfall with energy dissipater

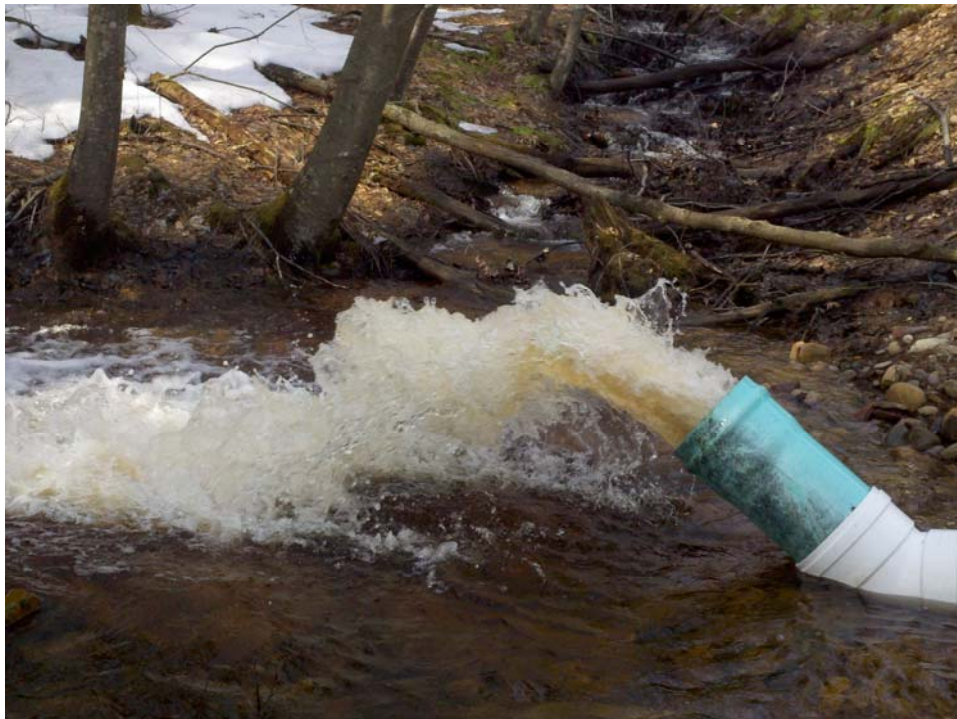
Mine 2b during spring 2011 high flow
