# **West Side of Lower Kettle Creek AMD Remediation Master Plan**

**February 2007**

**Developed for Trout Unlimited  
and the Kettle Creek Watershed Association**

**by Hedin Environmental**

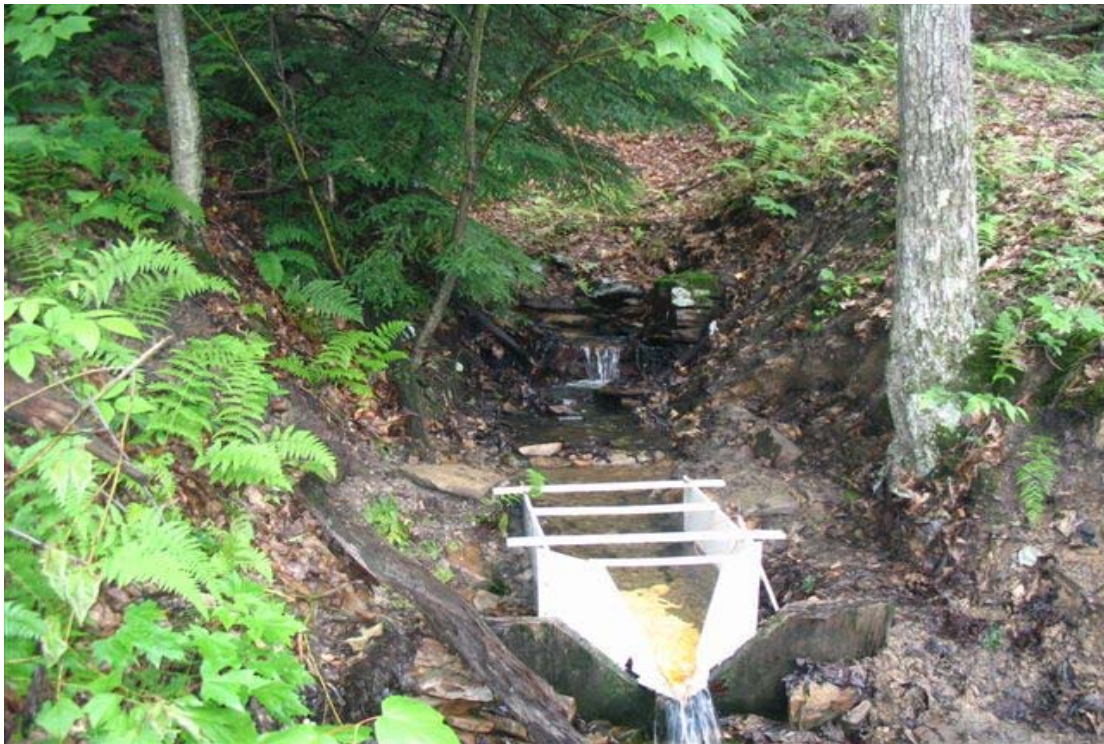
*The KC204 discharge, a drain from the Kettle Creek Coal Mining Company No. 1 Mine*

The KC204 Group includes KC204 and KC204A. The discharges are located in Sproul State Forest (Map 9). KC204 discharges from a WPA mine seal and flows down a steep slope directly to Kettle Creek (Photos 17 and 18). The discharge is the largest point source of AMD pollution to Kettle Creek. The discharge is considered in conjunction with KC204A because in the past most of the flow that is now observed at KC204 flowed from KC204A. There is a large kill zone below KC204A and a kill zone is developing below KC204. The magnitude of the KC204 discharge is a result of the design of the underground mine, which was designed to promote flow away from the busy portals in Bitumen at the inclined plane.
