KC204 Mine Pool Stabilization Project

**By Hedin Environmental
For Trout Unlimited & the Kettle Creek Watershed Association
June 2011**

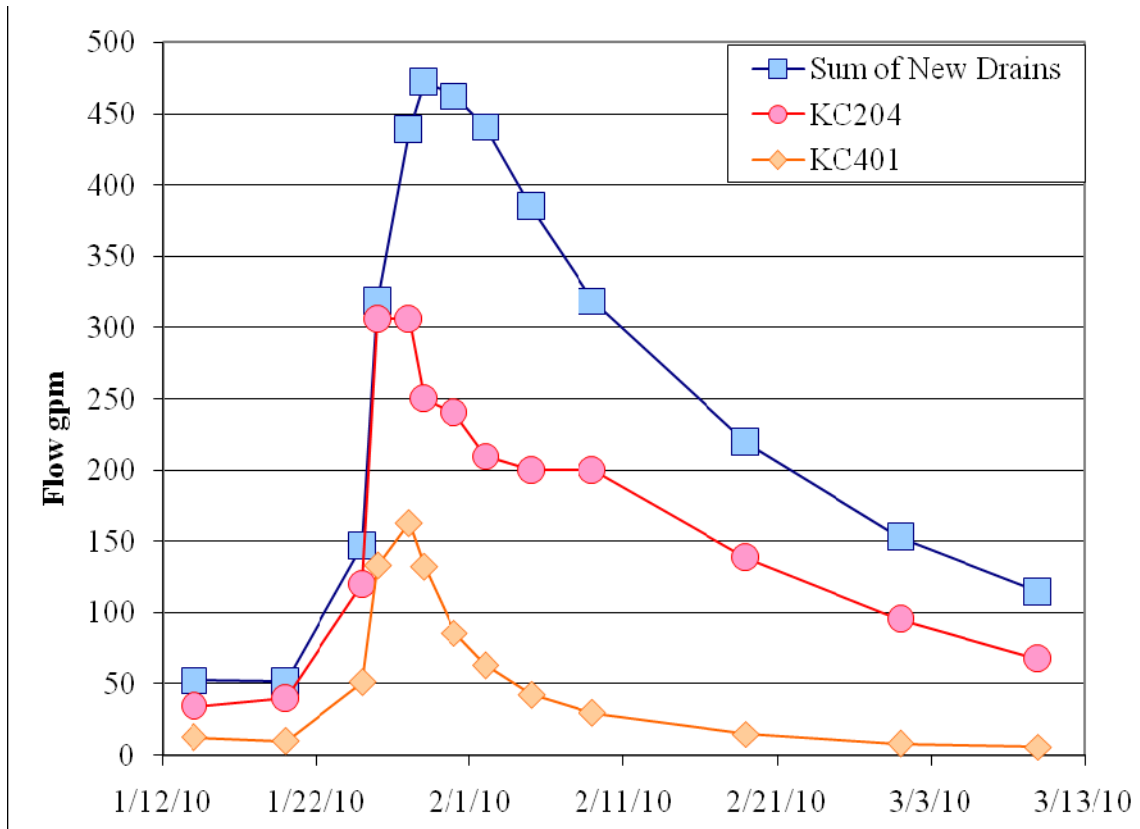
The two drains that were installed directly into the mine opening (Mine 1 and Mine2b) have had the highest flow rates. Within two weeks of reestablishment of the Mine 1, 2a, 2c and 3 drains (but before the installation of the Mine 2b drain) heavy rains combined with a rapid thaw quickly refilled the mine. Water levels in the mine and flow rates were intensely monitored to characterize the event. Monitoring of water levels in the mine and discharge flow rates showed how the mine fills and how the mine drains and the KC204 discharge responded. Figure 1 shows flow rates from the mine during this period.

Figure 1 Flow rate from new drains, KC204 and KC401 following heavy rains. Note the irregular curve as the flow declines from KC204. This suggests input from the adjacent pool in Mine No. 1.

Discharge flow from the mine began to increase first at KC204 and KC401. This agrees well with the mine structure indicated on the mine mapping that shows these two discharges have their own minesheds separated from the main mine workings. Once the slug of water from the local mineshed passed, the flow from these two discharges began to quickly decline. However, the rate of decline in flow from the KC204 discharge shows signs of influence from the adjacent No. 1 Mine. The break in the slope of the flow rate decline occurs at about the same time as the peak mine pool elevations were observed. This suggests that the mine pool was contributing to the flow at KC204.

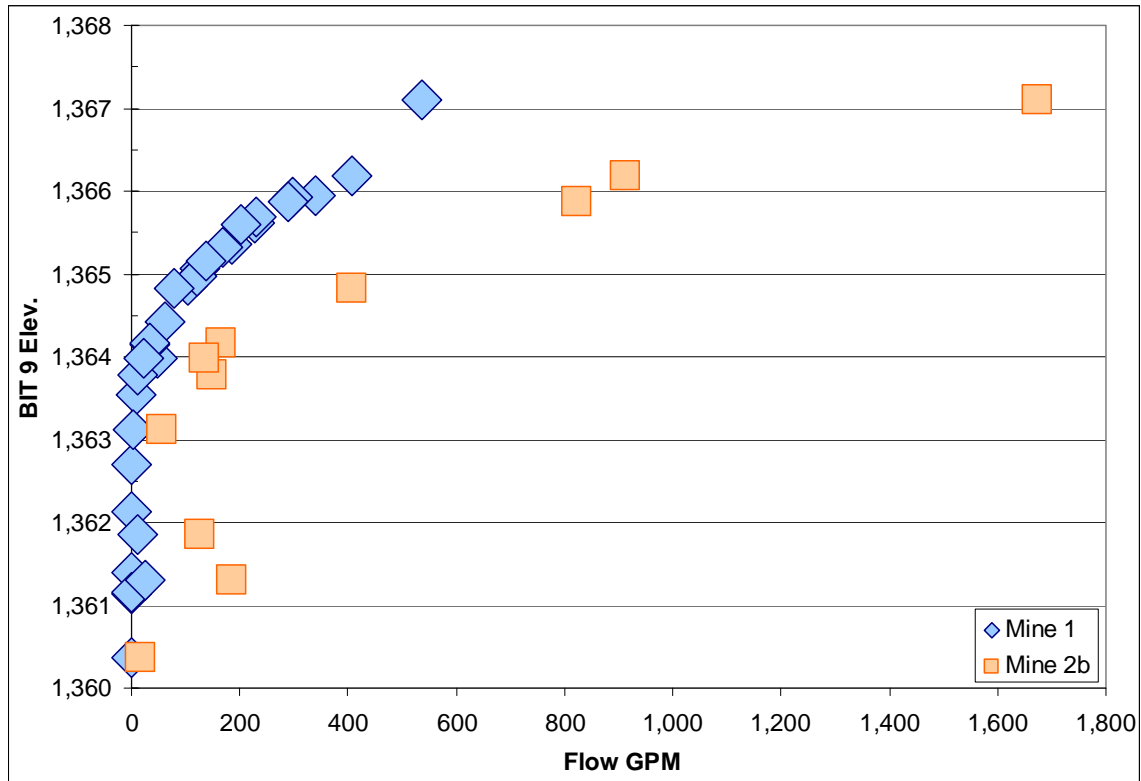
Further evidence for the connectivity between the new mine drains and the mine pool lies in the comparison of the mine pool elevation with the flow rate from the drains. Figure 2 shows the relationship between water elevation in monitoring well BIT 9 and discharge flow rate from Mine 1 and Mine 2b drains. The strong relationship indicates that the two are directly connected and that Mine 1 drain is an unrestricted outlet for the mine. Note

that the highest flow rate for Mine 1 is slightly off the curve established by the other measurements. This can be attributed to either measurement error of such a large flow or the pipe is nearing its capacity.

Figure 2 Relationship of flow rate from Mine 1 and 2b drains to water level in monitoring well BIT 9. (Elevation in feet above sea level.)

At mine pool elevations above 1,364 feet the Mine 1 and Mine 2b drains discharge water that would have largely flowed to Kettle Creek. The new mine drains give the mine pool the ability to discharge large flows at lower elevations. As a result the risk of mine pool blowout is reduced because the frequency of high head conditions that would lead to a blowout has been significantly reduced.

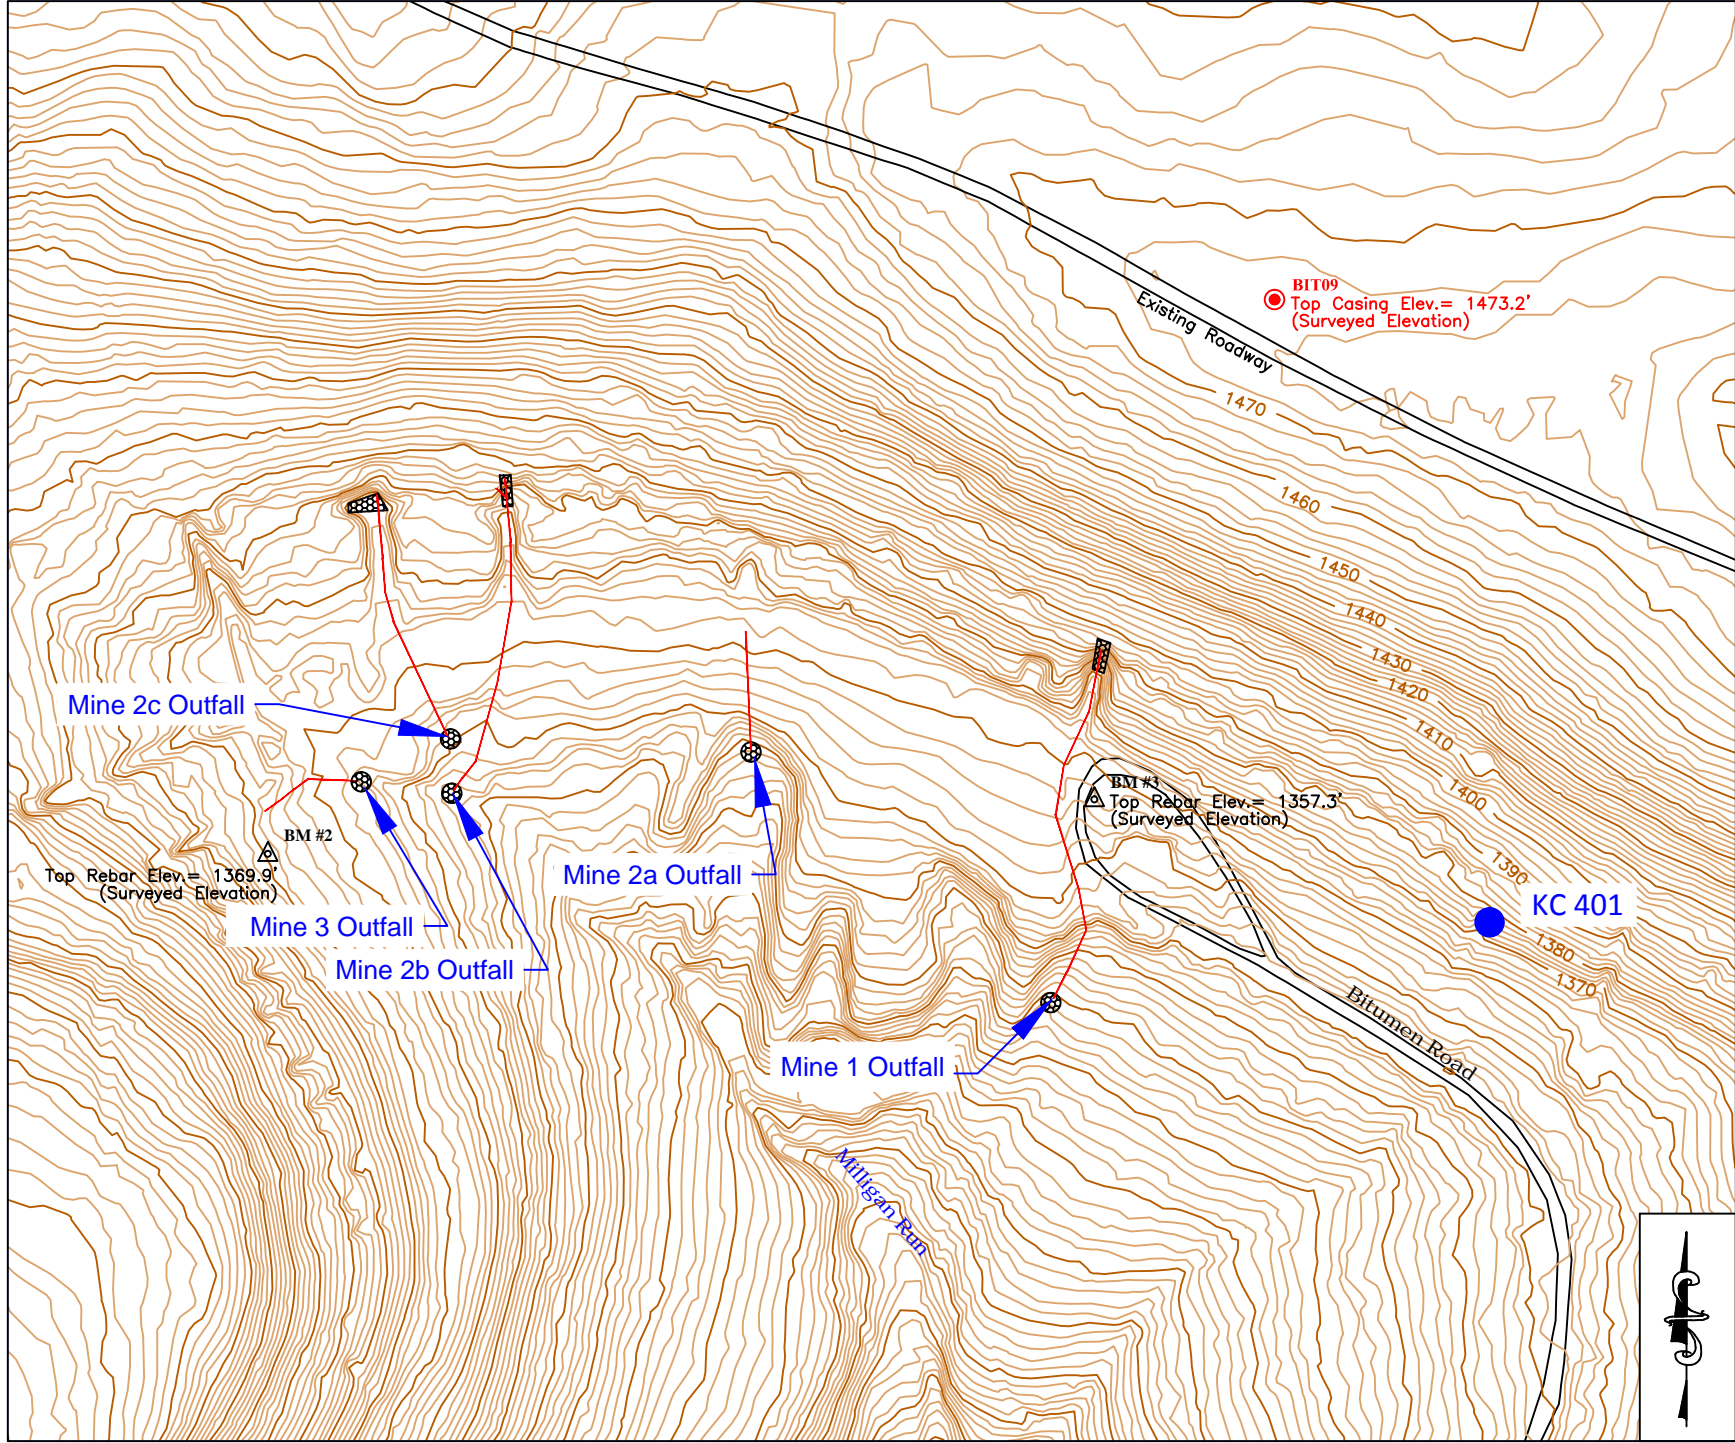
MAP C		KC204	
MINE DRAIN PROJECT LOCATOIN MAP		FILE NAME: BIT MAPS.dwg	
MUNICIPALITY: NOYES TOWNSHIP		DATE: June 2011	
COUNTY: CLINTON COUNTY, PA		DRAWN BY: NAW	
		SCALE: AS SHOWN

The Mine 1 entry was completely excavated and a drain was installed on the mine floor. The mine was dry at the time of excavation and evidence of a wooden box drain was found between the crossties of the railway. The new drain consists of 10-inch PVC perforated pipe in a bed of non-calcareous aggregate. A clay dam was installed across the mine opening immediately downstream of the perforated pipe to prevent leakage along the pipe. Solid 10-inch PVC pipe carried the flow from the mine entry to the discharge location 300 feet downslope to an existing kill zone. An energy dissipater lined with riprap was installed at the outfall to prevent erosion.

During the excavation of Mine 1 a pipeline was discovered that ran parallel to the coal crop toward the entries of Mine 2. The pipeline was excavated and found to consist of a mixture of 2-inch metal and wooden pipe. In front of the eastern most entry to Mine 2 (Mine 2a) the excavation encountered a large log cribbing that was filled with saturated sediment. The cribbing was located directly beneath an old weir for monitoring flow from the Mine 2a entry. Sediment was excavated from the cribbing which revealed a 12 inch clay pipe that had served as a drain for the mine. The clay pipe was discharging water. The land above the entry was severely subsided so opening the entry to replace the drain properly would involve significant excavation and was considered impractical. Instead, a 10-inch PVC pipe was connected to the existing clay pipe using a Fernco fitting. The PVC pipe was extended downslope to an existing kill zone where an energy dissipater lined with riprap was installed at the outfall to prevent erosion.

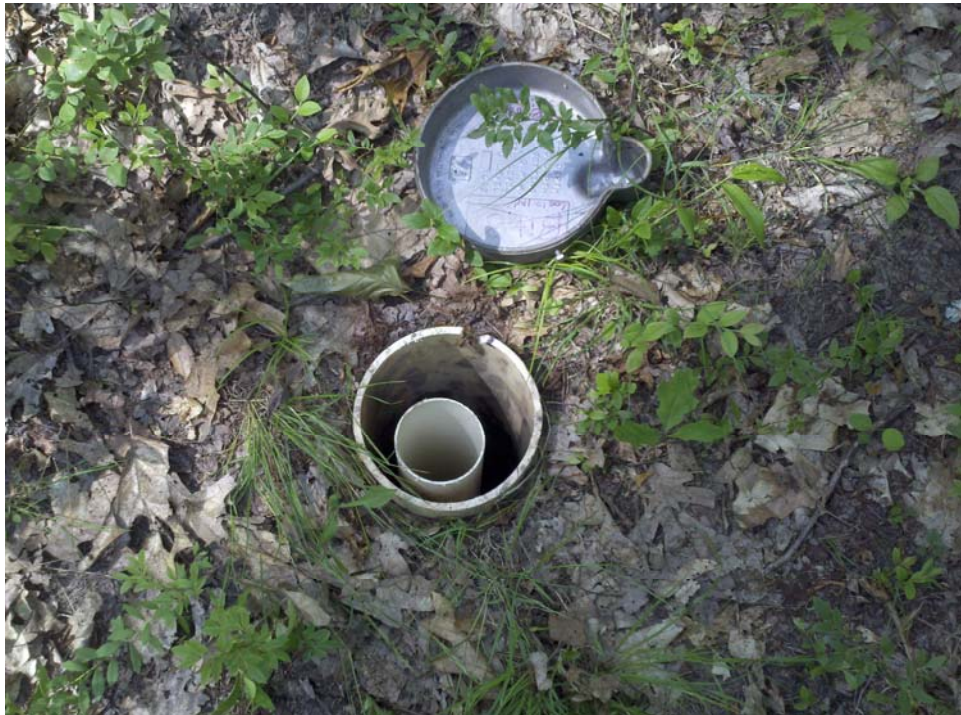
BIT 03 monitoring well casing.
